SPRING MILL DAM

LEHIGH COUNTY, PENNSYLVANIA

PHASE I INSPECTION REPORT
NATIONAL DAM INSPECTION PROGRAM

PHASE I INSPECTION REPORT
NATIONAL DAM INSPECTION PROGRAM
SPRING MILL DAM
NATIONAL ID NO. PA 00785
DER NO. 39-1

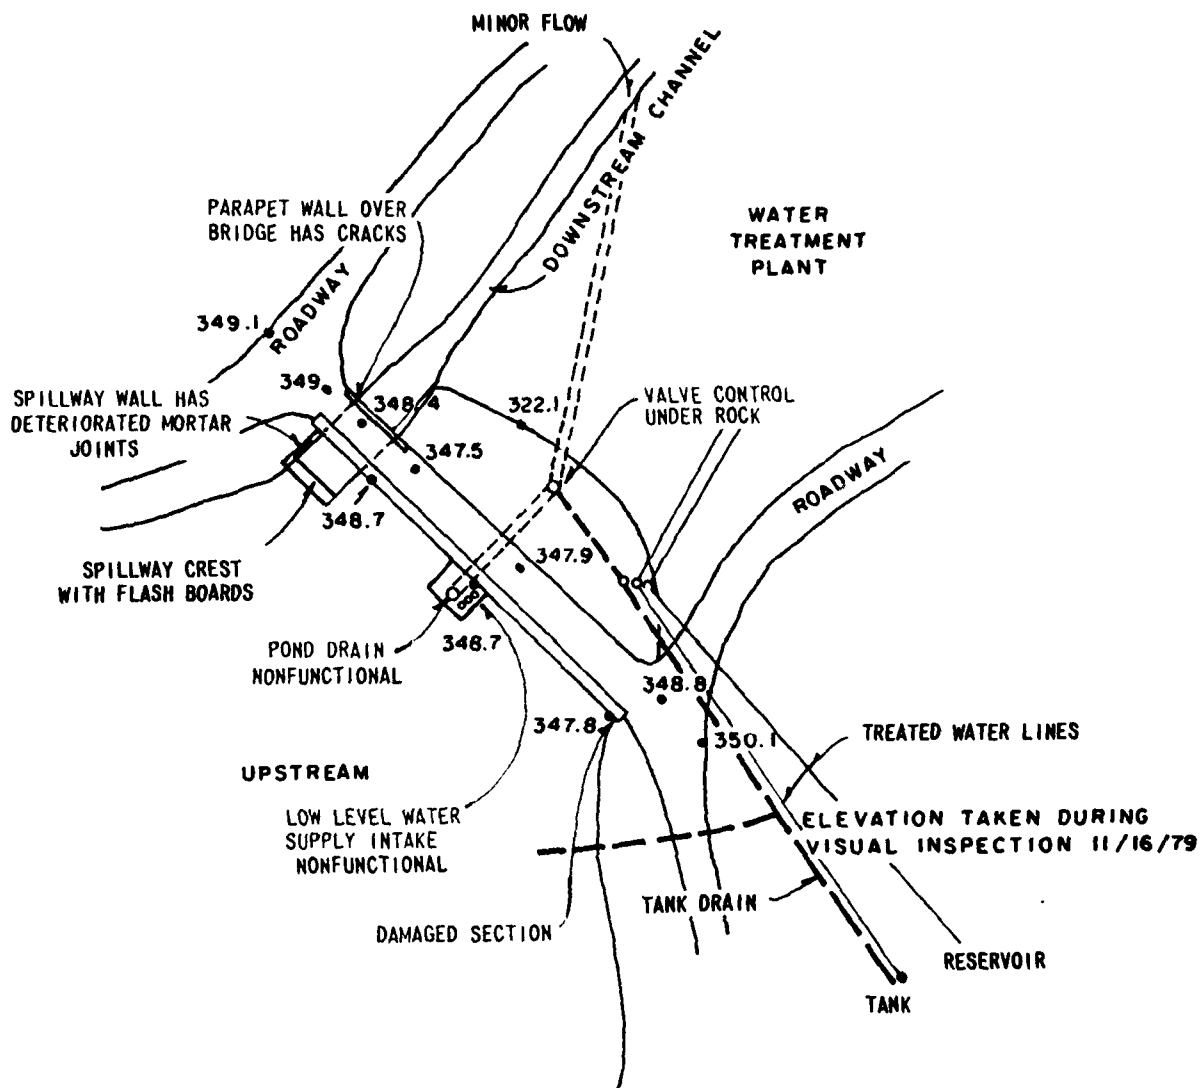
FIELD OBSERVATION PLAN
 SPRING MILL DAM
 SHEET 5A OF 11

1. Spillway. The spillway is "L"-shaped, as shown on sheet 5a, Appendix A, with the shorter leg perpendicular to the masonry dam. The longer leg is perpendicular to a retaining wall, which is parallel to the left abutment. Flashboards have been added to the spillway, as shown on Photograph 1. These flashboards are about 10 to 14 inches high and are held in place by pipes driven into the stone. It is assessed that these would fail during a large storm.

2. Outlet Works. The exposed portions of the masonry screen chamber, shown in Photograph 5, were inspected and appear to be in good condition. The wooden top could not be removed to inspect the interior of the chamber. The upper two intakes were exercised; the lower intake is inoperable. The pond drain conduit is gated at the upstream end and at the downstream toe. The upstream gate is nonfunctional, and flow through the pond drain is controlled at the downstream valve. A small amount of water was flowing through the pond drain conduit at the time of the inspection, as shown in Photograph 6. The original cast iron conduit has been extended by reinforced concrete pipe, and this discharges into the stream channel about 135 feet beyond the dam. Two other valves at the toe of the dam control the flow of water between the treatment plant and the reservoir and tank on top of the hill. A third valve controls the drain line from the tank. The drain line from the tank can also draw off water from upstream of the dam. A schematic diagram, as reported by the plant operator, is included on sheet 5a.

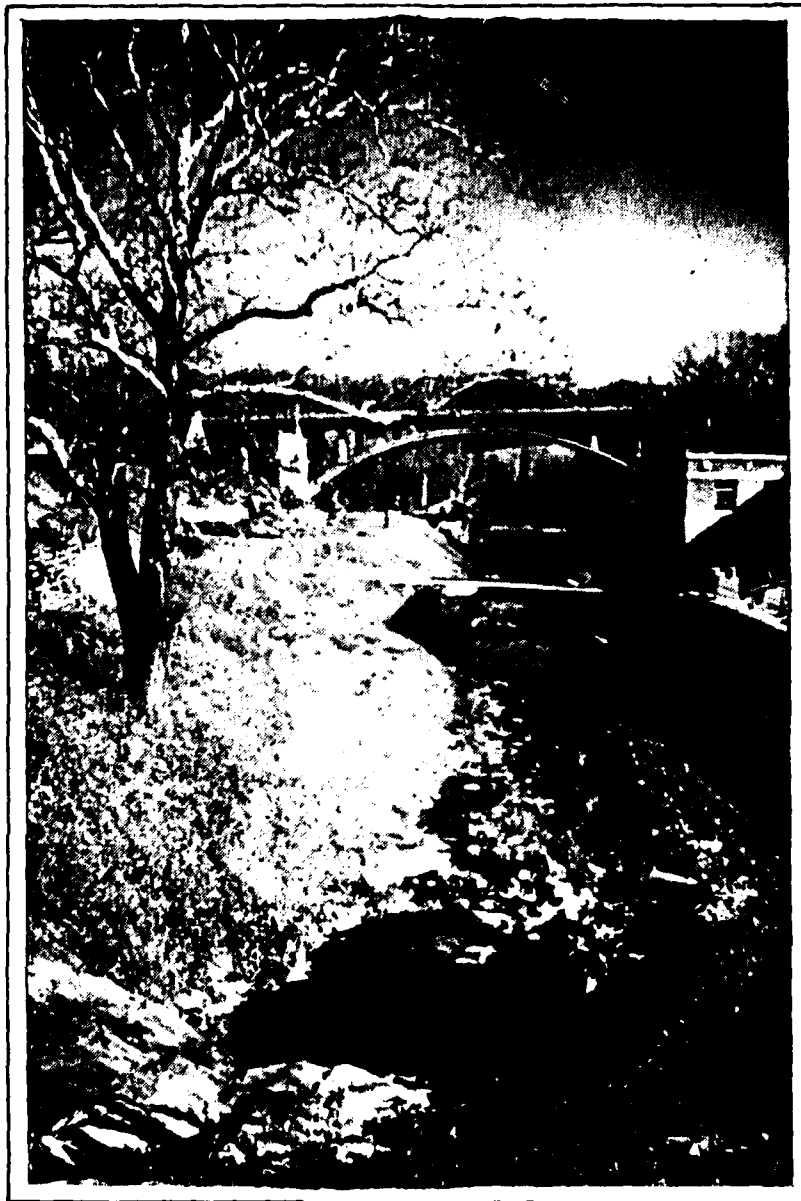
PHOTOGRAPH NO. 3

The spillway channel below the bridge, shown on Photographs 2 and 3, is assessed to be in good condition. Spillway discharge flows under the bridge and then over bedrock to a plunge pool located below the dam. The channel between the plunge pool and a downstream railroad culvert was rehabilitated in 1977.

f. Downstream Conditions. About 200 feet downstream from the dam is the major downstream hazard center, the water treatment plant. About 500 feet beyond the dam, the channel flows under a large concrete arch highway bridge, as shown in Photograph 3. About 800 feet below the dam, the channel passes under Conrail tracks, through the culvert shown in Photograph 4, and then discharges into the Lehigh River. Sudden failure of the dam would flood the water treatment plant shown in Photograph 3, and could possibly damage the plant and cause loss of life, as well as result in loss of the secondary water supply serving about 40,000 people. Therefore, because of the appreciable potential economic loss, a "Significant" hazard potential classification is justified.

VIEW OF DOWNSTREAM CHANNEL
AND DAMAGE CENTER.
